Embedded and Fractured Esophageal Self-Expanding Metal Stent

Clinical Image

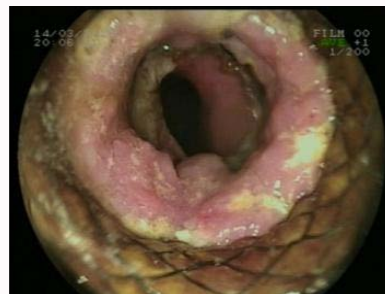
A 70-year-old hypertensive patient underwent right bilobectomy for pulmonary carcinosarcoma. Five days after the procedure, he presented esophageal fistula treated endoscopically by a 12 cm partially covered metal stent. The patient was lost of view during three months after procedure. He presented then for dysphagia. Upper endoscopy (Figure 1) and CT scan (Figure 2 and 3) showed an impacted and fractured stent. The stent could not be removed endoscopically due to the embedding of the uncovered stent ends in the oesophageal wall.

Figure 1: Upper endoscopy showing and embedding of the upper metallic stent end in the oesophageal wall.

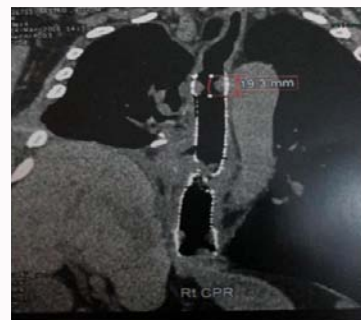
Figure 2: CT scan (coronal slice) showing an embedding of the two ends of the stents in the oesophageal wall with median fracture of the stent.

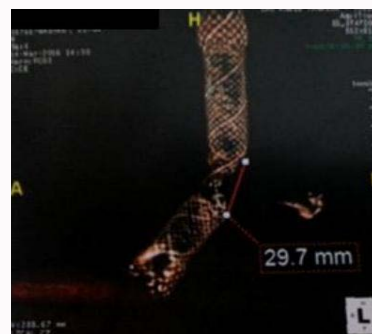
Figure 3: CT scan (reconstruction) showing the median fracture of the oesophageal stent.
