Mechanical Failure of an Angio-Seal Requiring Surgical Extraction

Abstract

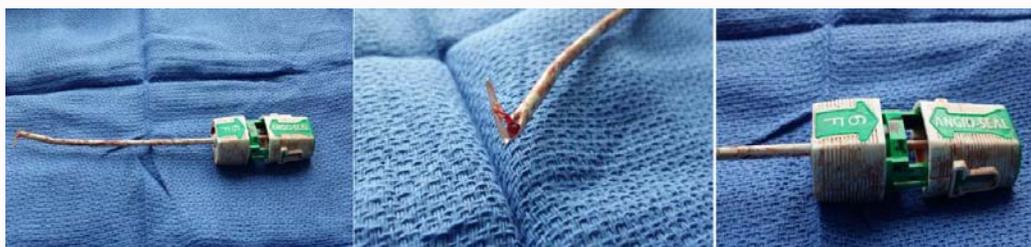
Figure 1: The 6F VIP Angio-Seal™ device after surgical extraction from inside the artery.

Analysis of the malfunctioned device by St. Jude Medical Company revealed failure of with subsequent failure of deployment of the collagen plug and the sandwich mechanism.

A 6F VIP Angio-Seal™ was chosen as a closure device for femoral artery access site. The insertion sheath and the arteriotomy locator were advanced over a long guide wire into the femoral artery by standard technique with no difficulty. A good pulsatile flow exiting the arteriotomy locator port was obtained. The locator was removed and the compaction tube was advanced through the insertion sheath until the click, which indicates the protrusion of the foot plates out of the sheath, was heard. The compaction tube was pulled back, but the second click, which indicates locking of the tube into the sheath, was not obtainable despite multiple attempts. Gentle pulling on the whole Angio-Seal™ system was associated with resistance. Forceful pulling was avoided to avoid shearing of the artery. We realized the mechanical failure of the device, which was then left in place and hemostasis was achieved via manual compression. The patient remained hemodynamically stable with no symptoms throughout this event, although he had mild mottling of the left leg and decrease of the dorsalis pedis pulsation. Emergent vascular surgeries consult recommended exploration of the left femoral artery and surgical extraction of the device. The device was extracted and there were no signs of fracture or missing pieces of it (Figure 1). The common femoral artery was repaired with a bovine pericardial patch. Following revascularization, there was normalization of the leg color with regaining of the dorsalis pedis pulsations. The patient was discharged home the next day. On a follow up after a week, he continued to be asymptomatic with intact distal pulsations.
