Mechanism of Type III Failure of Constrained Hip Arthroplasty with Intact Locking Ring

Theodoraki M. Mechanism of Type III Failure of Constrained Hip Arthroplasty with Intact Locking Ring. *Ann Orthop Surg Res.* 2019; 2(1): 1008.

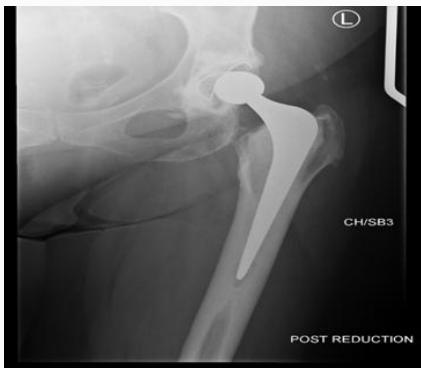
Figure 1a: X-ray image of primary hip replacement.

A 81 year old female patient, with a BMI of 31.6, presented to us with history of recurrent dislocation following a cemented total hip replacement which was performed 15 years ago (Figure 1a). This patient was asymptomatic for the first 10 years following her hip replacement. She then had five episodes of dislocation of the hip joint (Figure 1b) and all occurred while performing trivial, activities such as getting up from a chair. As she was asymptomatic in the initial 10 years, any cause related to poor surgical technique was ruled out. Nonetheless, she was investigated for infection and

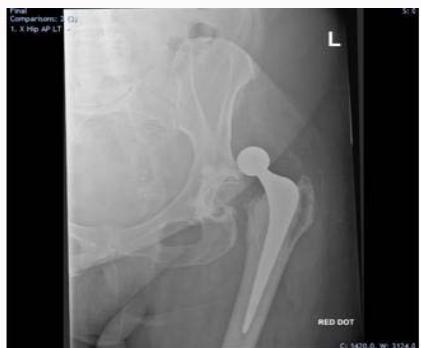
Figure 1b: X-ray image of dislocated primary hip replacement.

implant wear. Her initial radiographs of the hip joint suggested wear of the polyethylene cup due to the eccentric position of the femoral head.

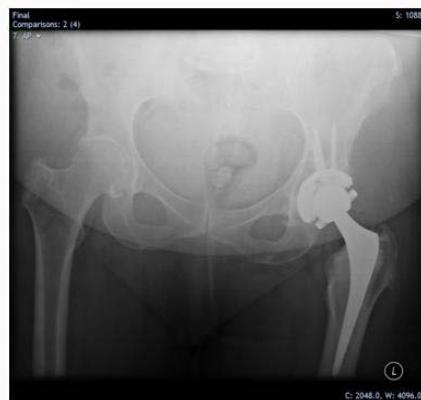
Figure 2: X-ray image of revised hip replacement with constrained liner.

After discussing the risks and benefits of a revision hip arthroplasty, this patient underwent revision surgery in December 2017 (Figure 2). She was treated with a constrained acetabular liner in view of her old age, history of recurrent dislocation and poor soft tissue around the hip joint (intraoperative finding). The revision surgery was performed with a Pinnacle multi-hole cup (uncemented) and a constrained acetabular liner.

During revision surgery it was noted that there was significant wear of the original polyethylene cup as suspected preoperatively. We also noticed that external rotators of the hip joint were detached and thus these posterior structures were repaired intraoperatively to provide additional stability.

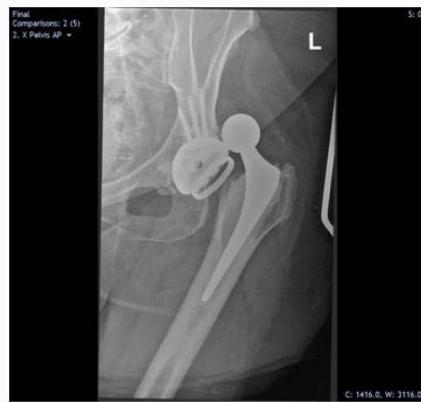
This was well fixed and the constrained liner was entirely within the metal socket. However, the locking ring was still completely intact and has decoupled from the liner. It was also found that hip abductors were deficient, and the flanges of polyethylene liner were damaged both anteriorly and posteriorly. Intraoperative assessment of the acetabular cup did not reveal any issues with the position of the cup which could have led to impingement. We believe that the primary cause of wear of the liner both anterior and posteriorly was reduced femoral offset. Hence, the damage plastic constrained liner (54 × 32) and the metal head (32 mm + 1.5) was replaced with

Figure 3: X-ray image of dislocation of revised total hip replacement with constrained liner intact.

This patient remained asymptomatic for 6 months but in June 2018, she dislocated the hip joint (Figure 3) which again happened while she was getting up from a chair.

a constrained liner (54 mm + 4) and the femoral head (32 mm size + 9) which increased the offset and in turn its improved abductor tensioning and hip stability. Once again, every attempt was made to repair the posterior structures and since her last revision surgery, she has remained asymptomatic.

liner, the metallic ring was intact in this case. We believe the possible mechanism is impingement of the neck against the polyethylene liner which caused gradual wear of the anterior and posterior flanges. It is possible that consistent impingement of neck against the liner lead to disengagement of the metallic ring from the liner and lead to dislocation. The common factors which can lead to this type of impingement are low head-neck offset ratio, reduced medial offset and poor orientation of the acetabular cup i.e. excessive adduction or abduction and ante or retroversion. We believe that a constrained liner can be used for recurrent dislocation of the hip, but surgical technique should not be undermined. Basic concepts of hip replacement, which includes correct implant positioning, maintenance of the offset and appropriate repair of the soft tissue also play a significant role and can influence the final outcome.
