Unexpected Complication of a Hybrid Breast Augmentation: A Case Report

Al-Sousi ASN, Kapadia A, Mohsin T. Unexpected Complication of a Hybrid Breast Augmentation: A Case Report. *Ann Plast Reconstr Surg.* 2023; 7(1): 1103.

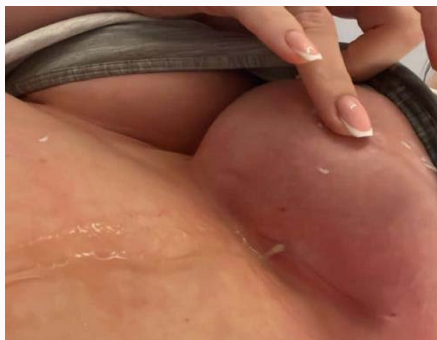
Figure 1: Upon presentation to the Emergency Department. The left breast is inflamed and is oozing a seropurulent discharge.

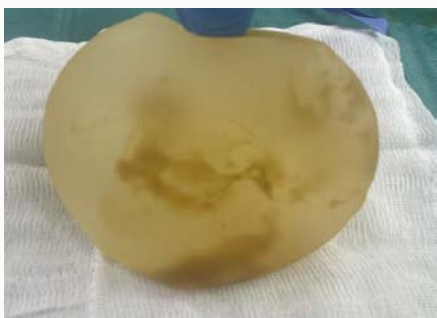
Figure 2: The implant emphatically showing a foreign substance within it, confirmed to be adipose tissue and pus.

The surgery for implant removal and washout was performed by Senior Author (AK). With the patient under general anesthesia, an incision was made over the previous surgical incision and observed was a round and microtextured 265cc, silicone implant in the subglandular/subfascial pocket. The implant was taken out, it showed needle track marks, multiple pores that leaked fluid upon squeezing and was infiltrated with fat tissue and pus (Figure 2 and Video 1).

After removal of the implant, the pocket was washed with a triple antibiotic solution, debrided where needed and wound was closed leaving only a 15 French silicone drain. The patient was significantly better in terms of pain and her clinical condition improved. The drain was removed 2 days later. The patient was discharged on IV antibiotics for 48 h twice a day postoperatively. She subsequently received oral amoxicillin and clavulanate antibiotic course for a duration of 5 days empirically and a pain relief medication.

1. When possible, after completion of fat harvest, fat transfer can be done before insertion of the implant – this step would directly eliminate the complication.

2. Implant should preferably be placed in a dual plane or submuscular plane for added safety.
3. When we are doing implant exchange or have significant asymmetry, requiring the use of a sizer, we leave this in place and fat graft around the sizer. If there is inadvertent damage, it is to the sizer only, finally placing the implant as the last portion of the operation.

4. Patient should be made to sit up at 45 degrees for better visualization of implant borders and circumventing the implant pocket with the cannula. The assistant can help to apply gentle pressure on the implant in downward direction, while the surgeon is placing fat in the upper pole of the breast.

5. Fat should be transferred in a subcutaneous plane and no attempt must be made to go deep.
6. Entry at the superior border of the nipple areola complex gives excellent access to the superior and medial poles of the breast, which are the areas we most commonly fat graft.

7. Introducing the cannula at parallel angles to the implant, rather than perpendicular can also help.
8. Blunt canulae with 16 G or 18 G should be used and fat injected in a retrograde fashion.

9. Avoid the use of smaller fine canulae as this may increase chances of implant perforation.
10. An intraoperative ultrasound can be used to be sure the plane of fat transfer.

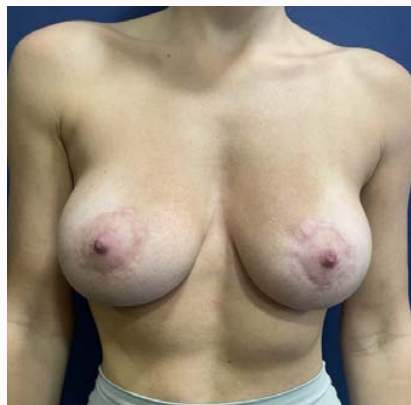
Figure 3: Final follow-up picture after the re-symmetrisation procedure, 5 months after the first presentation.

Five months later, the patient visited us in the plastic surgery clinic to discuss her postoperative scars. Examination was unremarkable with good symmetry in the two breasts, Grade 2 ptosis and no palpable lumps or swellings in breast or axilla. Figure 3 is the final photograph taken of her breasts displaying her current status.

was not replaced yet. The patient did undergo the symmetrization procedure with her primary surgeon.
